VORTEX BREAKDOWN ON A DELTA WING

Submitted by F. M. Payne, R. C. Nelson, and T. T. Ng
(University of Notre Dame)

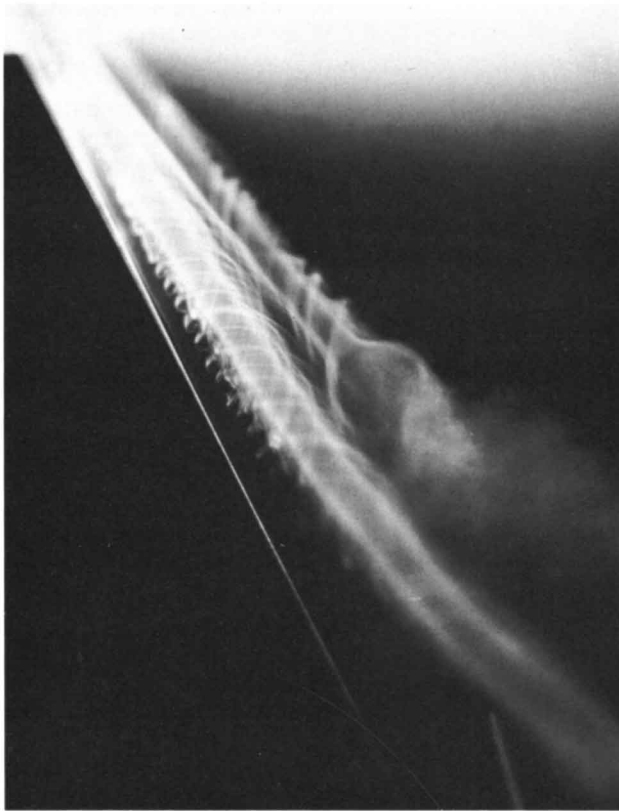
Figure 1

The above photographs show the breakdown of a leading-edge vortex on an 85° swept delta wing at a 40° angle of attack. The freestream velocity is 10 ft/sec. For highly swept wings at high angles of attack, the vortices tend to break down asymmetrically. In the photograph at the upper left, a column of smoke introduced upstream of the test section

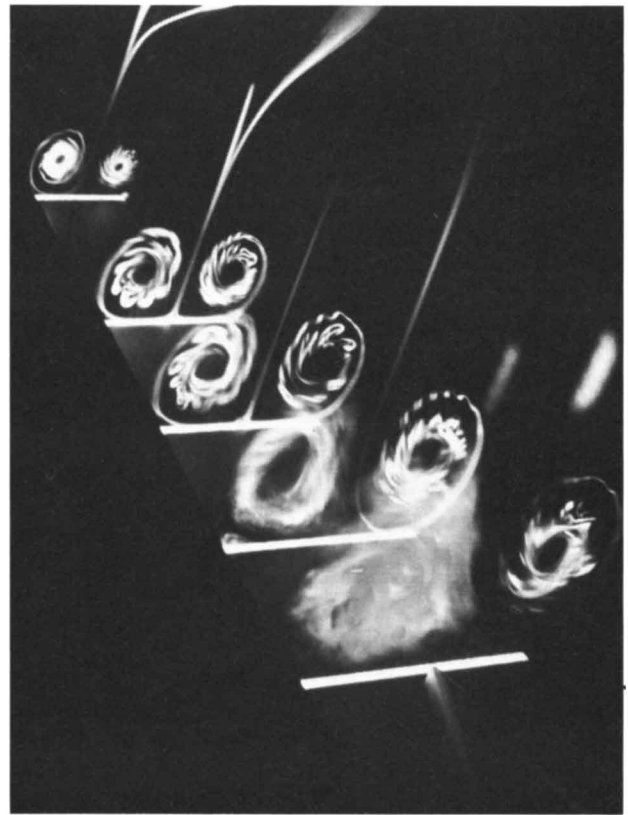
Figure 2

impinges on the apex of the model and is entrained into the vortices. The right vortex is breaking down at $x/c = 0.50$. The photograph at the upper right was obtained using the laser sheet technique. It is a multiple exposure showing five lateral cross sections of the flow field. The fourth cross section from the apex is cutting directly through the "bubble" region of the breakdown. The bottom photograph is a longitudinal cross section of the vortices obtained by rotating the laser sheet by 90° . A region of high-speed axial flow occurs in the core of each vortex and appears in the photographs as an area void of smoke.
